TALGO, INCORPORATED

NTSB Accident Number: RRD-18MR001

Proposed findings in relation to the behavior of the railroad rolling stock involved and recommendations for improved safety in connection with the derailment of Amtrak Train 501, DuPont, Washington, Dec. 18, 2017

FINAL SUBMISSION

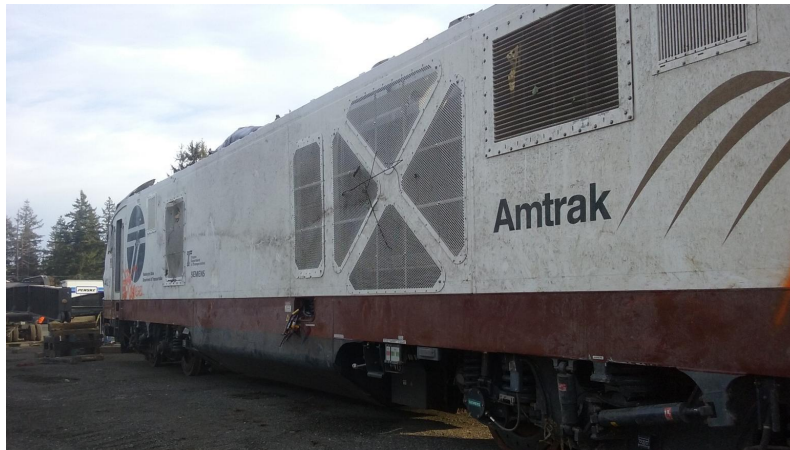
Figure 7 Locomotive condition after the accident (left side)

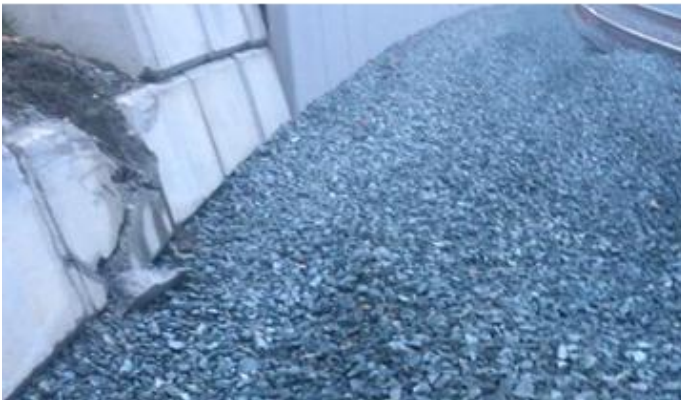
Figure 8 and 9 show evidence of impact of the locomotive against the retaining wall to the right and the distant signal for the Nisqually control point, MP 21.3. (The debris at the right in Figure 8 is from the signal.)

Figure 8 Retaining wall condition after the accident

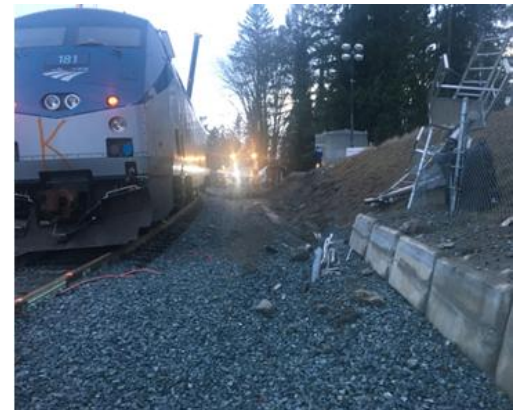
Figure 9 Wall and signal mast condition after the accident

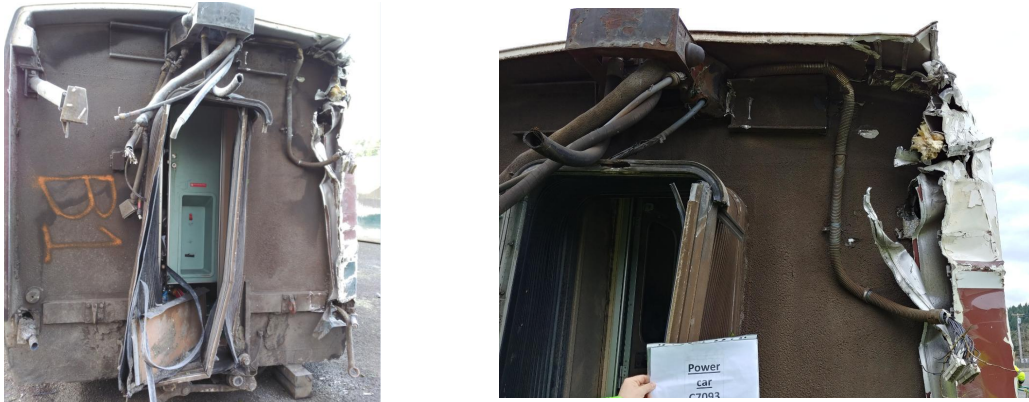
During the accident power car 7903, C1 7454, C2 7554, dining car 7804 and bistro 7303 suffered in-line collisions confirming that Talgo trains distribute deformation along the train as anticipated in the Arthur D. Little report. The pictures that follow show evidence of the in-line deformations.

Figure 31 power car 7903. car to car interactions

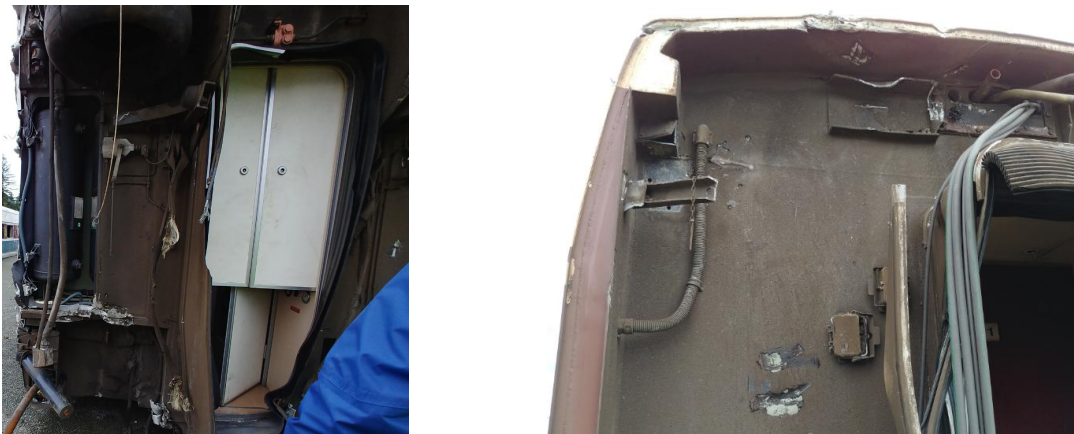
Figure 32 C1 7454. Car to car interactions

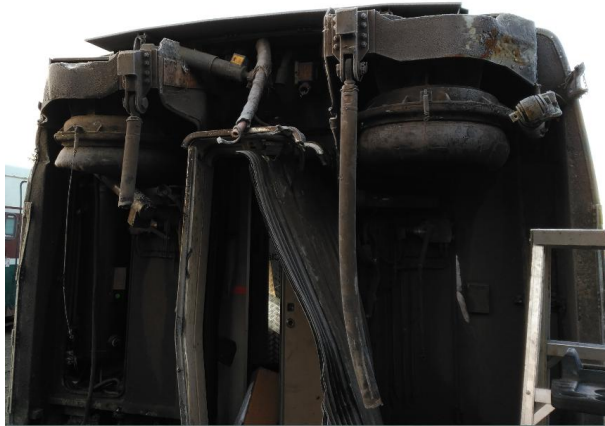
Under the loads indicated in CFR the most critical condition is the buckling failure of the bars. This condition was apparent in several cars such as diner 7804, bistro 7303 and C5 7423. This effect is shown in Figure 39 to 41, where no failures of attachments are detected but severe deformations of suspension tower supports did occur. These deformations show that the forces produced during the accident greatly exceed the 100,000 pounds required by the current regulation.

Figure 39 diner 7804 weight bearer bar buckling

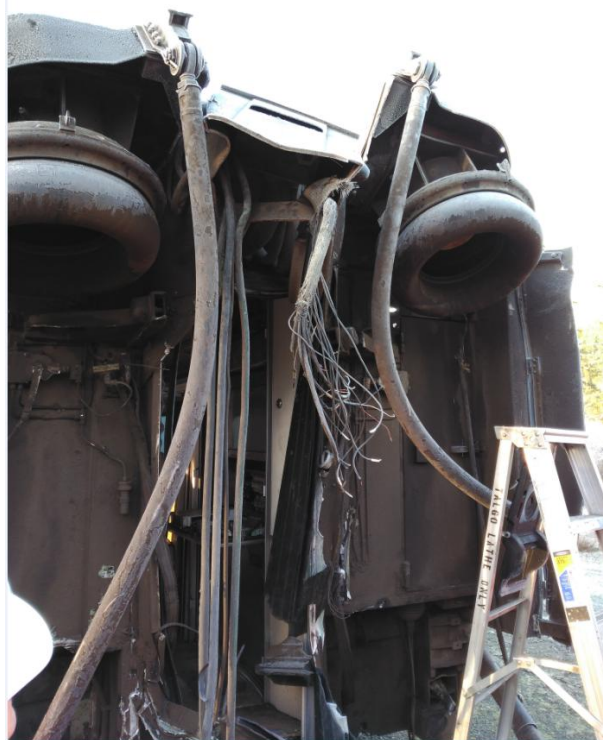
Figure 41 C5 7423 weight bearer bar buckling

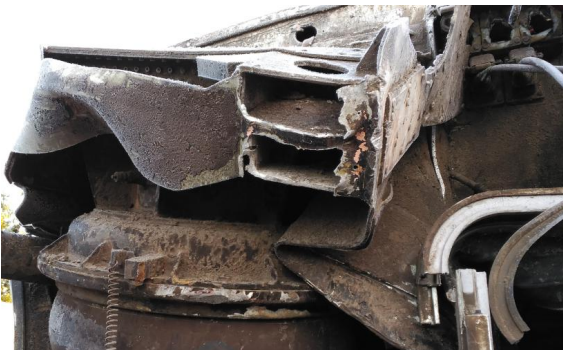
In some cars the aluminum plate where the weight bearer bars were attached had been torn off from the tower support. This failure was caused by very high forces as can be inferred from Figure 43 and 44, where the car body structure was severely deformed by these vertical loads.

Figure 43 C7 7421 tear off detail

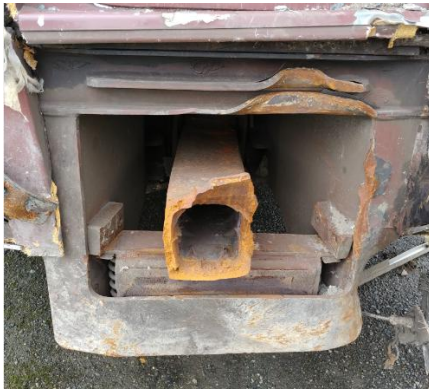
The couplers on Talgo end cars are Type H Tightlock couplers in accordance with AAR (now APTA) standards (Talgo Technical Specification ET-0213). This coupler on power car 7903 was broken due to the forces produced when the buff forces (produced by the decelerating locomotive) caused lateral forces that rotated power car 7903. Post-accident inspections reveal deformations consistent with torsional and bending loads in the power car and the locomotive. Figures 45 and 46 show torsional and bending deformations on the power car coupler. Figure 47 and 48 show the torsion effects on locomotive coupler.

Figure 45 Power car 7903. AAR coupler (1)

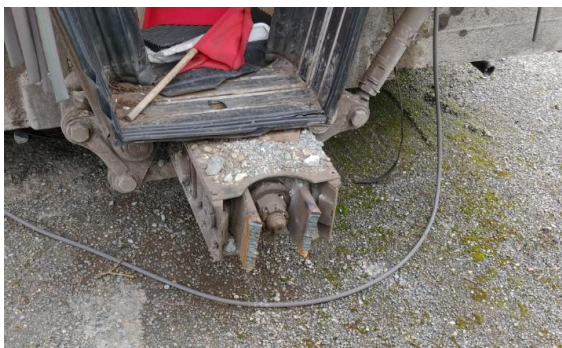
Articulated connections were subjected to various types of loads depending on the car to which they were attached. The articulated joint between power car 7903 and C1 7454 was broken due to the rotation of the power car described in 2.4.5 above. For the connections between C1 7454, C2 7554, diner 7803 and bistro 7303, the couplers were subjected mainly to compressive forces, and it was necessary to cut off the bolted supports to release the cars.

Figure 49 C1 7454. Coupler detail supported end

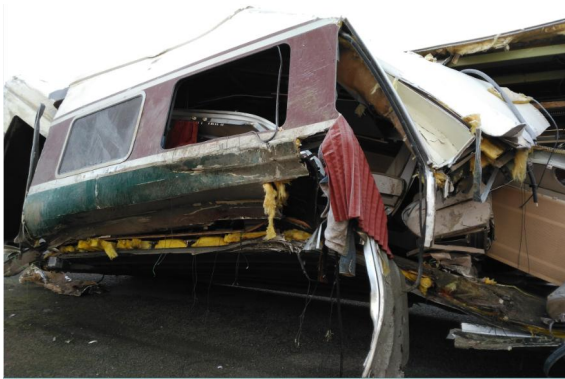
According to the accident sequence described in 1.2, C3 7504 received a high speed side impact against the overpass approach fill retaining wall, causing extensive damage at that point (and possible immediately following this collision). As can be seen in Figures 53 through 56 below, this extensive damage could not have been produced by the truck that detached from C6 7422, three cars to the rear, but it could have easily been produced by impact with the concrete wall. One block from this wall, which was partially demolished by the impact for the train, is visible immediately to the left of the detached truck in Figure 56. All three deceased passengers were in this car.

Figure 53 C3 7504. Side impact evidence (1)

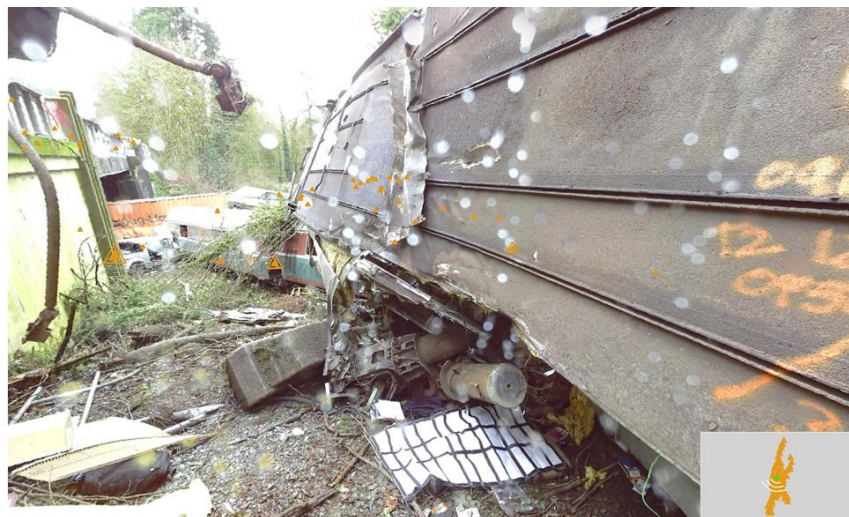
Figure 56 C3 7504. On site

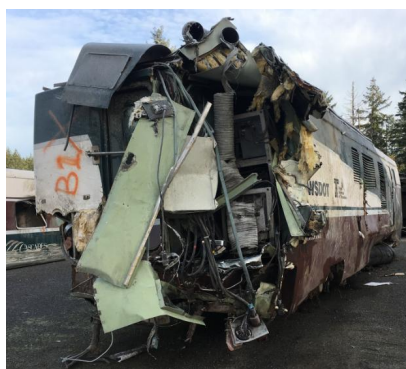
While severe damage to the end fairing of power car 7103 was apparent during the inspection at JBLM, the steel structure that forms the collision posts was found to be undamaged. (See Figures 61 and 62)

Figure 61 7103 Power car. End detail (1)

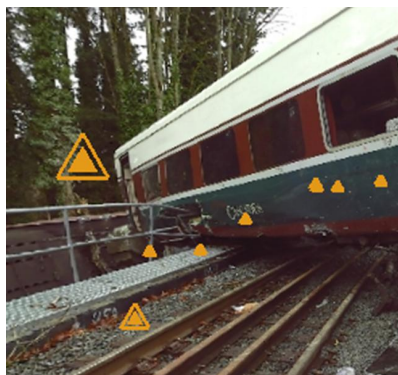
According to the investigation, some seats rotated due to various causes, but no defects attributable to design or maintenance were found. In C5 7423 the root cause was the lateral collision against the overpass. Metal debris from the bridge was found in this car. That damage caused the rotation of some seats, some of which were actually fixed (non-rotating) seats. In C4 7422 and C2 7554 rotated seats were examined with no defects found.

Figure 63 C5 7423 Metal debris intrusion

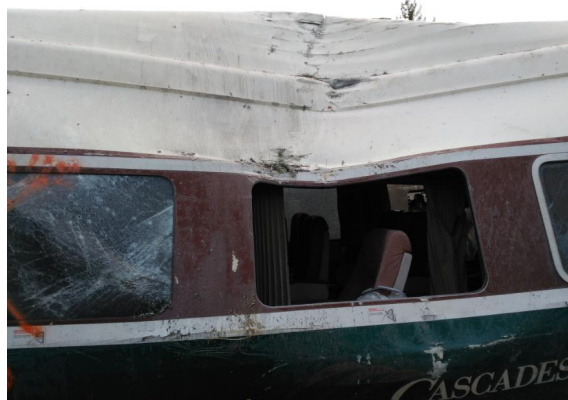
The rotation of seat 4C in C2 7554 was clearly caused by the deformation of the left side after C3 7504 came to rest on it. That deformation is clearly visible in Figure 64.

Figure 64 Left side deformation of C2 7554

Deformation of the sides broke the seats loose from their bases, allowing them to rotate; no defects of the attachment of the seat bases to the car body structure were found.

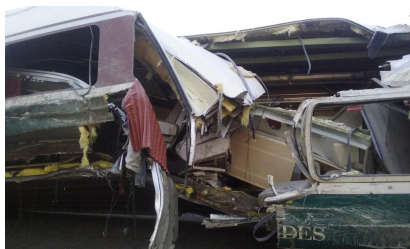
Figure 84 C3 C7504 damage, left side, detail (1)

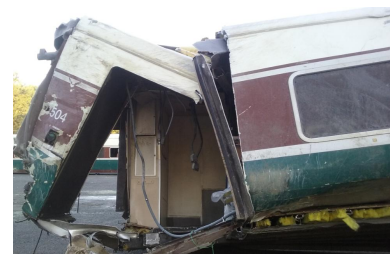
Figure 85 C3 C7504 damage, left side, detail (2)

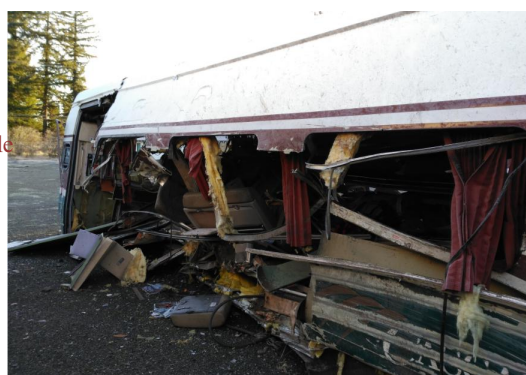
At the bridge entrance, C4 7424 hit the walkway railing, generating the longitudinal cut observed on its right side (in the direction of travel). Under its own inertia and probably being pushed from behind, this car tore off a part of the bridge, falling down onto I-5. It turned upside down with the supported end towards the back and the suspended end forward. Due to the impact against the highway, this car's truck (RGG-0082) also fell onto I-5. It came to rest in the left lane under the bridge after being pushed there by a vehicle on the highway that struck it.

Figure 89 C4 7424. Right side damage

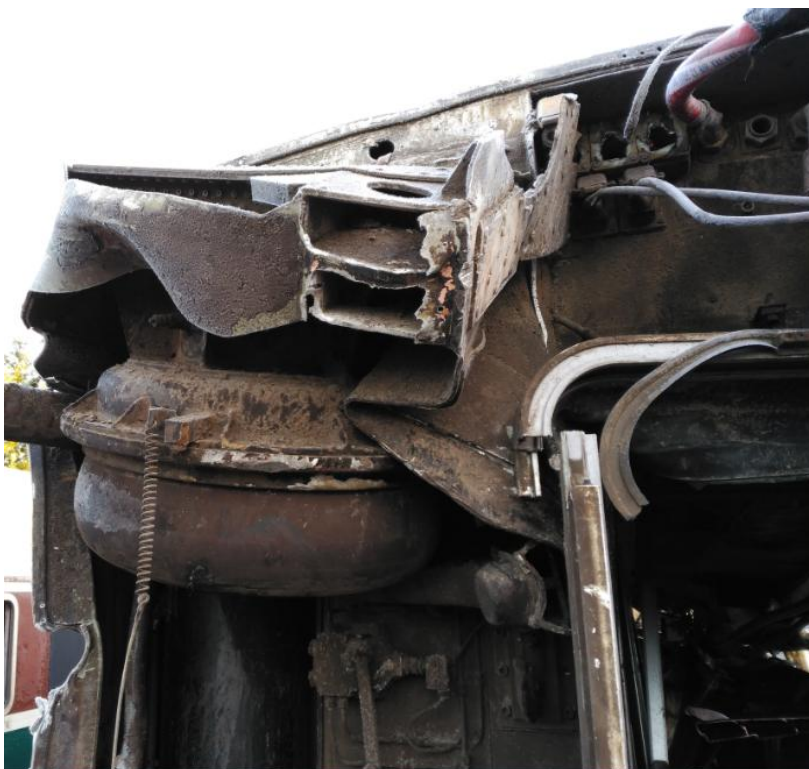
During the accident sequence, C4 7424 was subjected to much more severe side and roof impacts than those required by the CFR. The car fell onto its roof under dynamic, not the “quasi static” conditions of 49 CFR 238.215, and then, while it was resting on its roof and supporting some additional weight from C7 7421, substantially increasing the vertical load, it was struck on the left side by the combination tractor semitrailer that was southbound on I-5, the condition anticipated by 238.217 for an otherwise

Figure 94 C4 7424 Deformation due to vertical impact

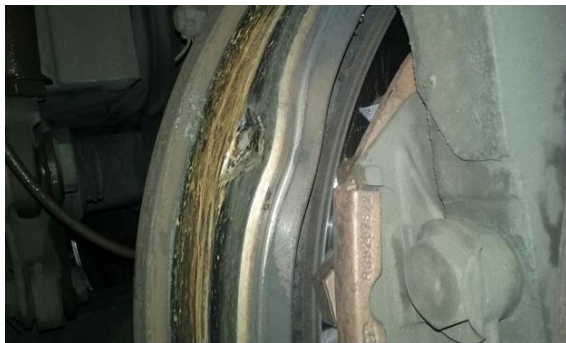
Figure 110 Damaged left wheel, rolling assembly car 6

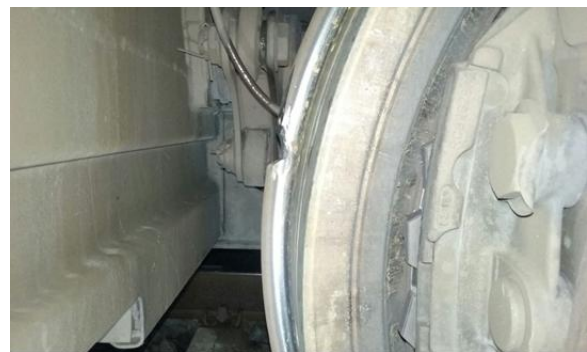
Figure 111 Damaged left wheel, rolling assembly car 7
